Miscellaneous Paper CERC-93-2  
March 1993

*Coastal Engineering Research Program*

## **Scour Hole Problems Experienced by the Corps of Engineers; Data Presentation and Summary**

*by W. Jeff Lillycrop, Steven A. Hughes  
Coastal Engineering Research Center*

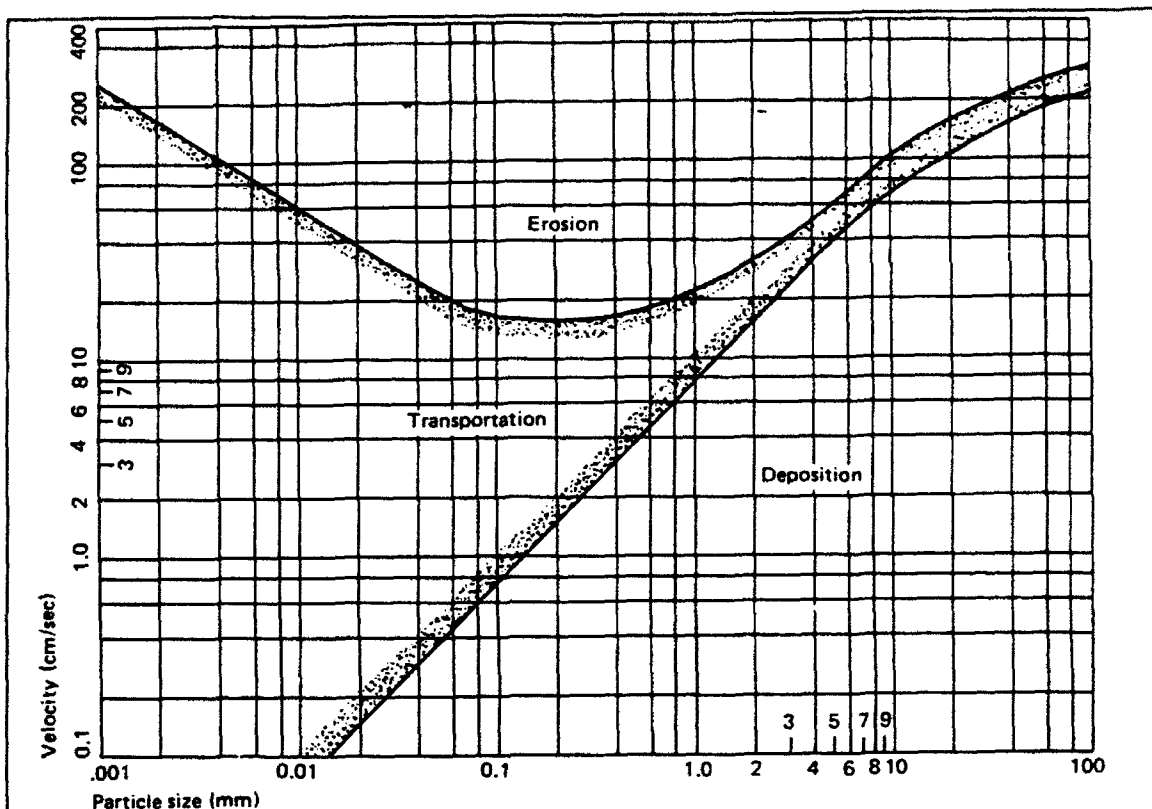
Figure 45. Sediment transport regimes as a function of velocity

For scour hole development to occur there must be currents of sufficient magnitude to move sediment. Figure 45 presents velocity versus particle size, and identifies when erosion and deposition are expected (Reineck and Singh 1980). Most of the case studies presented have fine to medium sands (0.01 mm to 0.3 mm); thus, a current magnitude of less than 20 cm/sec (approximately 0.7 ft/sec) can initiate sediment transport and erosion. Projects

like Indian River Inlet, Delaware, and Shinnecock Inlet, New York, have velocities greater than 200 cm/sec (6.5 ft/sec).
